United Pacific

# TURN SIGNAL SWITCH

Item # 5007R

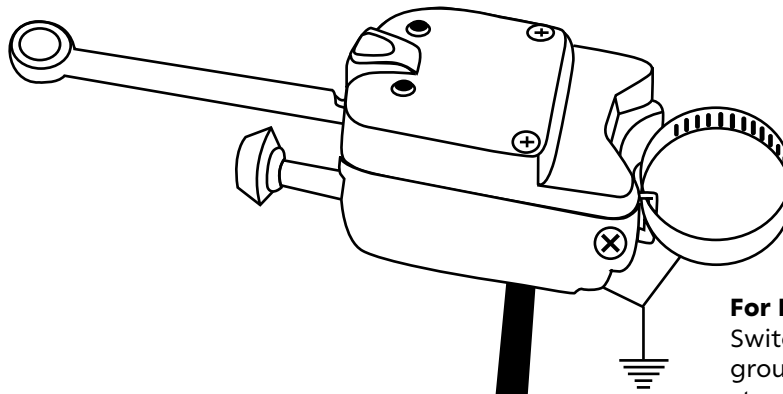
**For Internal Indicator Lamp:**  
Switch housing must be grounded by contact with metal steering column

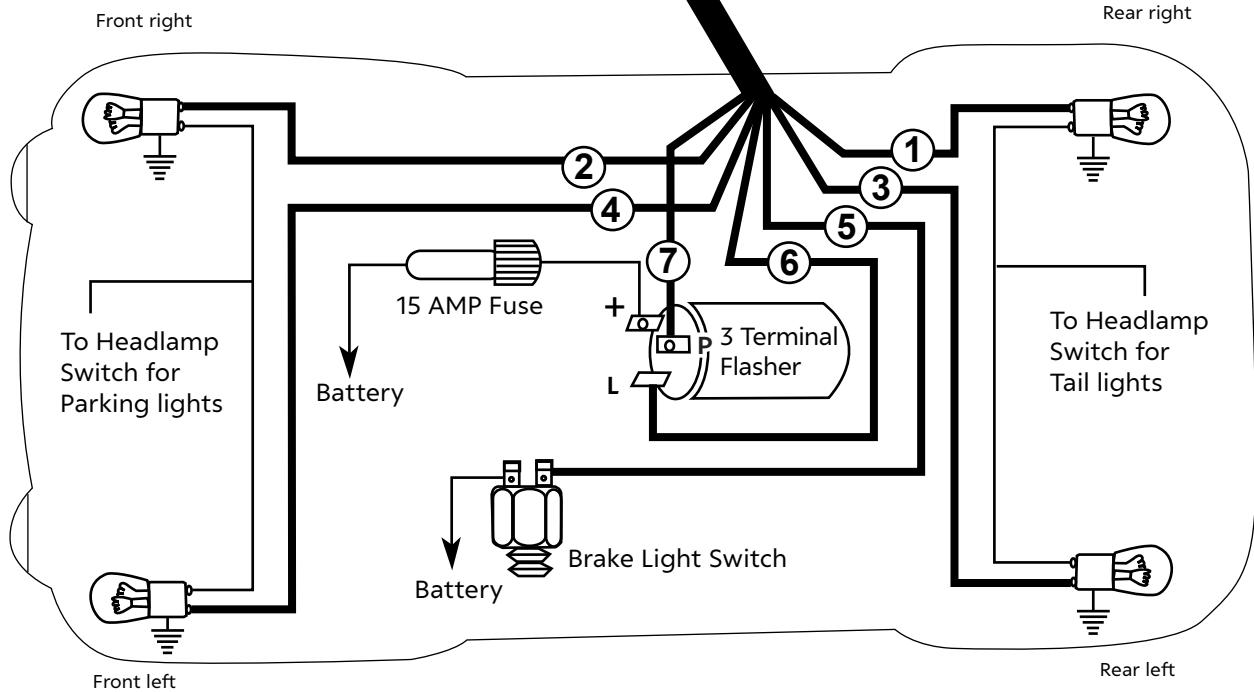
- Brown — **1** — Right rear flasher lamp
- Green — **2** — Right front flasher lamp
- Orange — **3** — Left rear flasher lamp
- Yellow — **4** — Left front flasher lamp

- Red — **5** — Stop switch
- Black — **6** — Flasher L terminal
- Blue — **7** — Flasher P terminal  
(For indicator lamp inside switch)
-

= Negative ground on car body
